# PLAY AREA SAFETY INSPECTION REPORT

## Puddletown Parish Council

This report issued June 29<sup>th</sup> 2023

Park Name: Butt Close Play Area

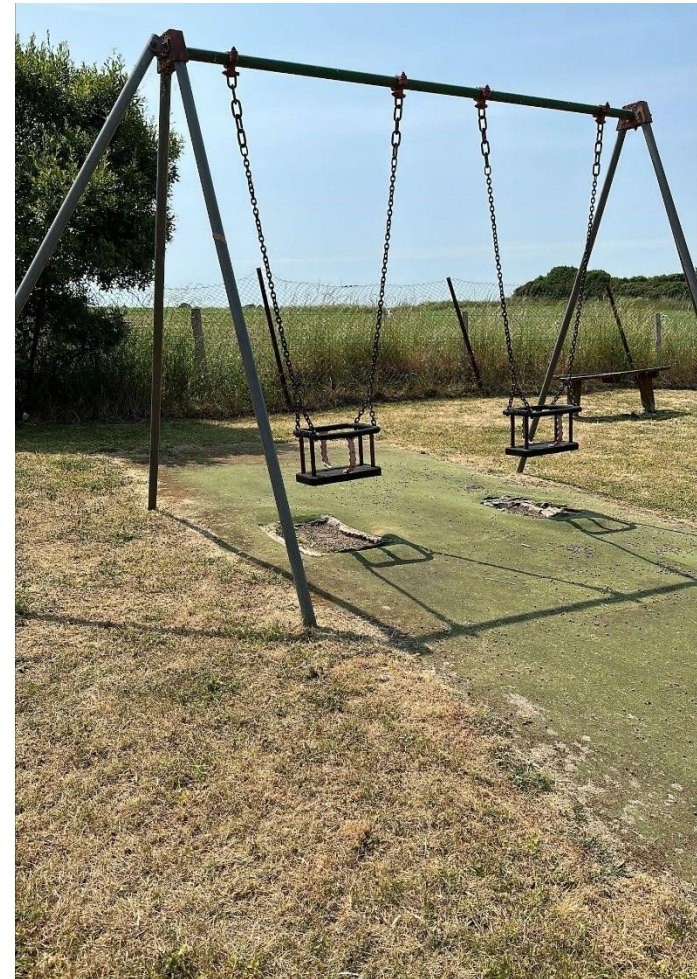
#### 4.1 *Twin Toddler Seat Swing*

| Item | Issues | Recommendation (s) |
|---|---|---|
| 4.1 | A patch to the grass matting has been removed. | Repair artificial grass. |

The artificial turf is worn and a hole is has formed. This is unchanged since the last report.

The swing frame predates the current standard and does not meet the requirements for clearance from the frame. This is an inconsequential finding, especially since the frame is fitted with Toddler Seats and will only be used under supervision.

The eroded areas remain unchanged.

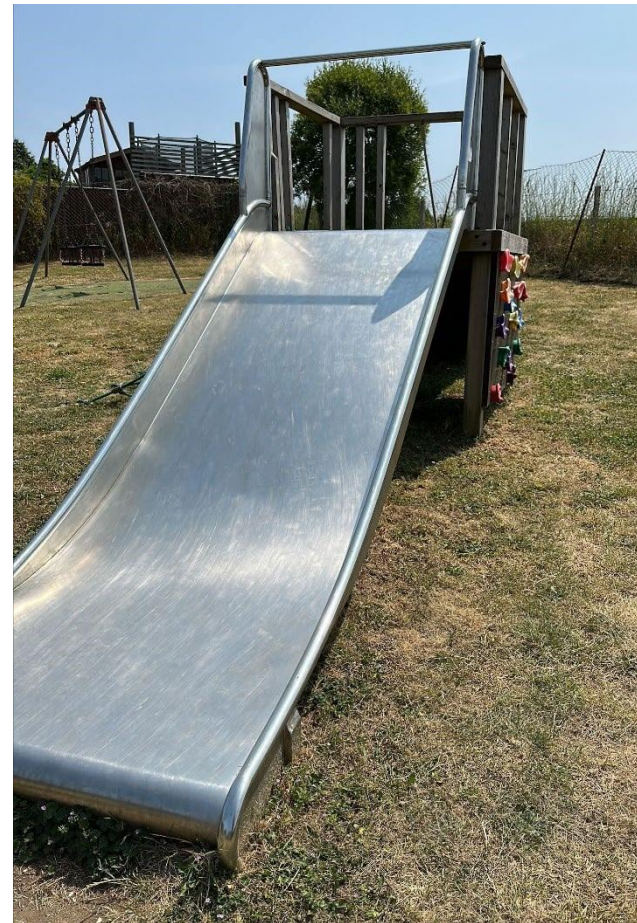
## 4.2 *Bespoke Multi Unit*

The unit and surrounding surface are in good condition although the timbers on the unit are due a wood preservative treatment.

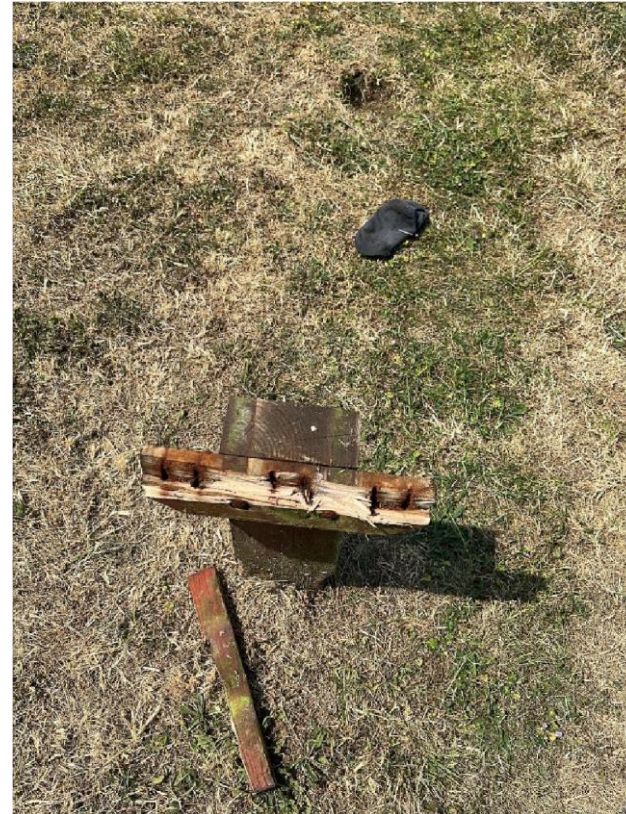
### 4.3 *Bench Seat*

The bench has been broken and removed.

Broken and removed.

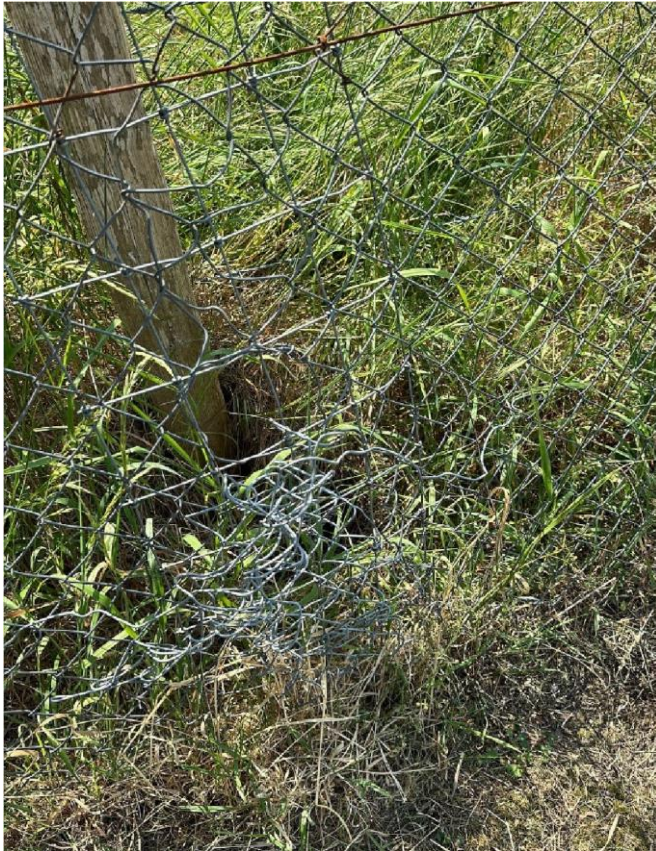
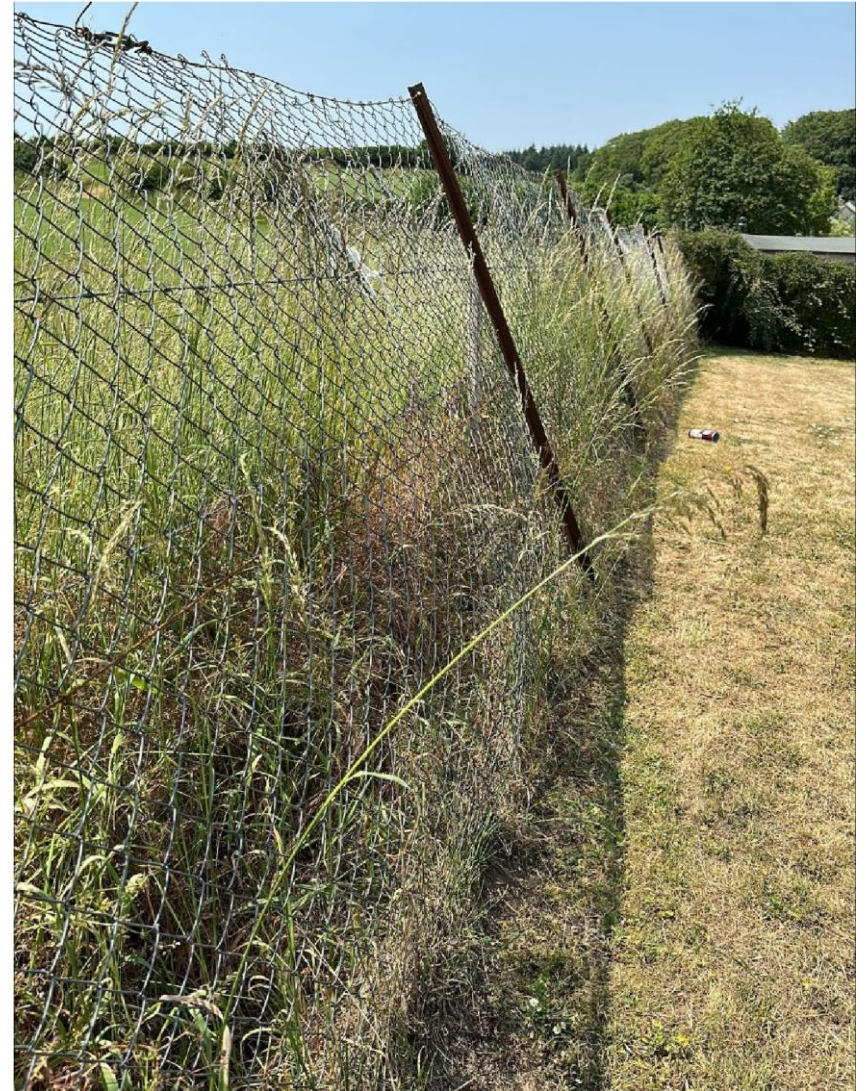
### 4.4 *Fencing*

| Ancillaries | | | | | |
|---|---|---|---|---|---|
| 1 | Fencing | Requires attention | 8 /Medium | Replace/remove chain-link fencing | Within 3 months |

The chain link fencing is a hazard which requires attention. In terms of health and safety law this is a foreseeable hazard to which there is a practicable, reasonable and affordable solution. Failure to implement a solution means that the council face issues of liability in the event of an accident.

The fencing issues here must be addressed.

| Item | Issues | Recommendation (s) |
|---|---|---|
| 4.3 | The chain link fencing and posts are broken | Remove or replace the fencing |

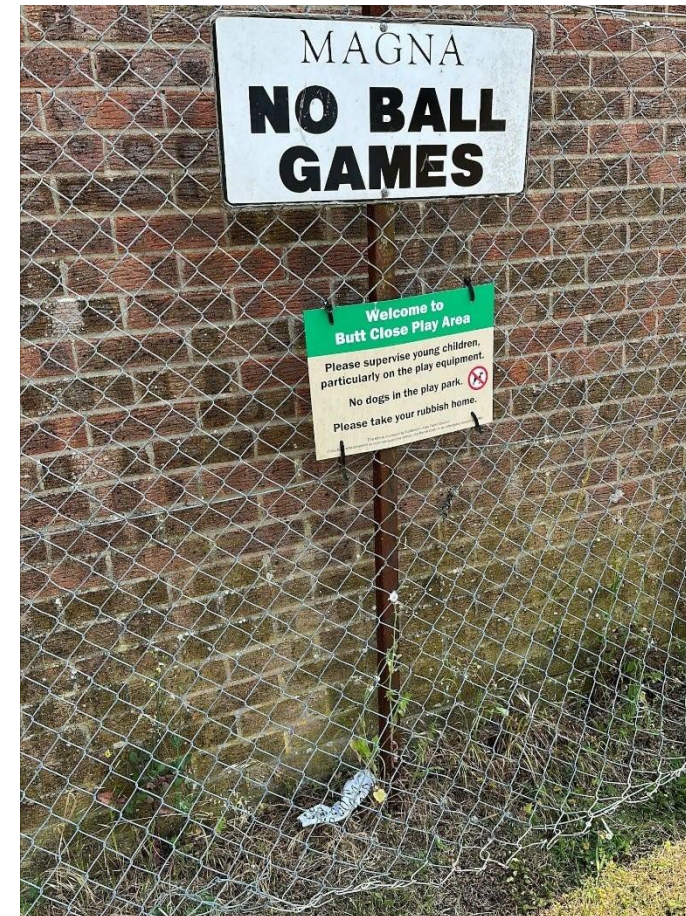
#### 4.5 Signage

| Item | Issues | Recommendation (s) |
|---|---|---|
| 4.4 | There is a No Ball games sign | Ask Magna to remove; there is no reason for it. |

Suitable signage is present
