# PLAY AREA SAFETY INSPECTION REPORT

## Puddletown Parish Council

Inspection undertaken June 2023

Park Name: Puddletown Rec. Play Area

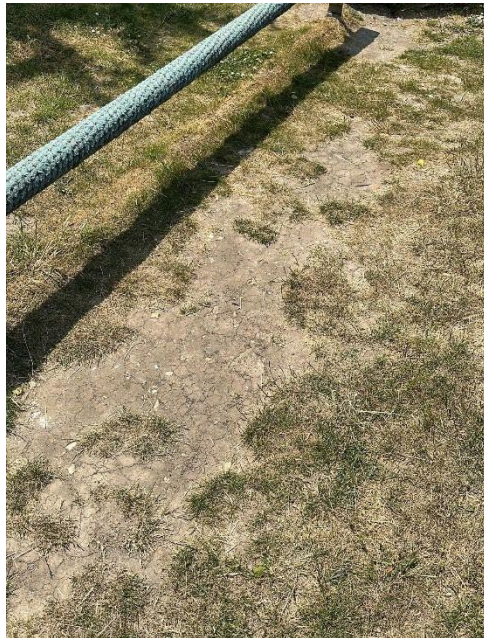
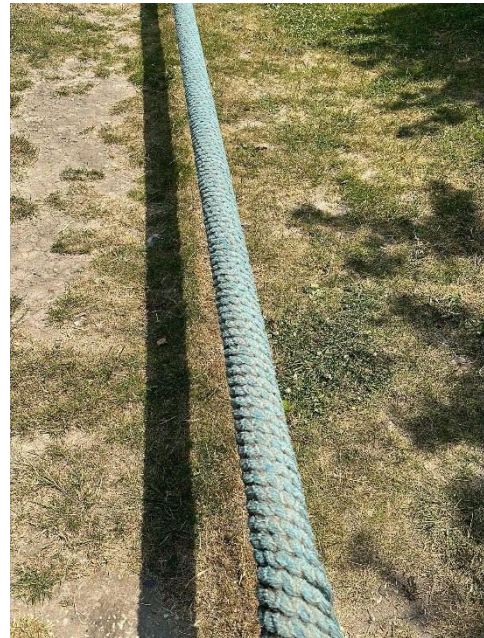
#### 4.1 Step Trail inc. Huck Slack Rope

Erosion near the slack rope is exposing stone and concrete in the fall area. This should be removed.

There are no current issues with this configuration of a combination of slack rope, boulders & stepping logs other than the exposed rocks and concrete in the fall area – which should be removed.

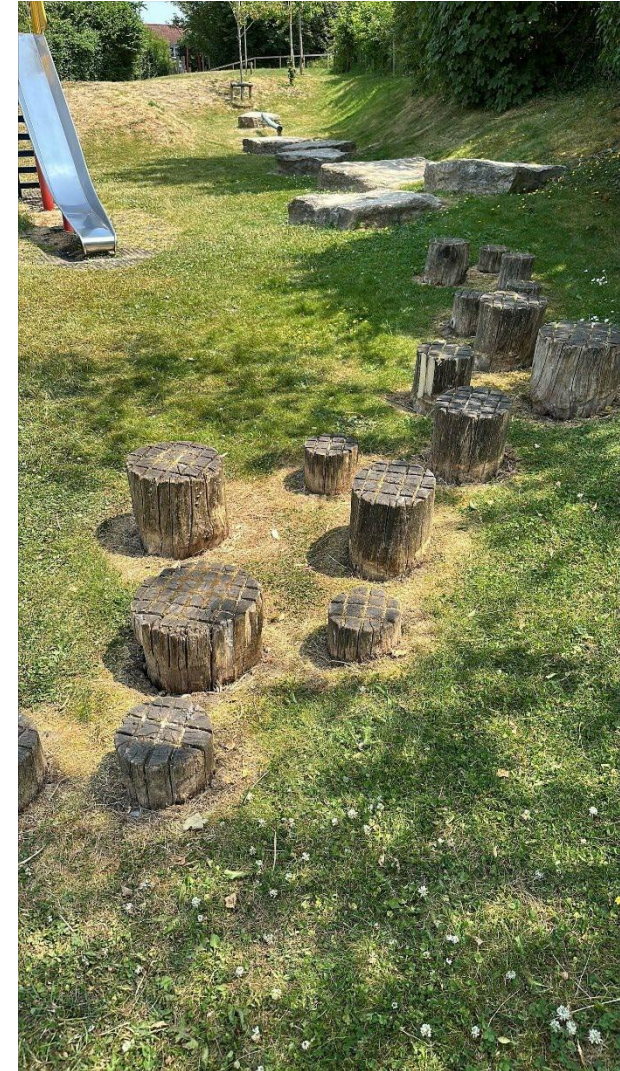
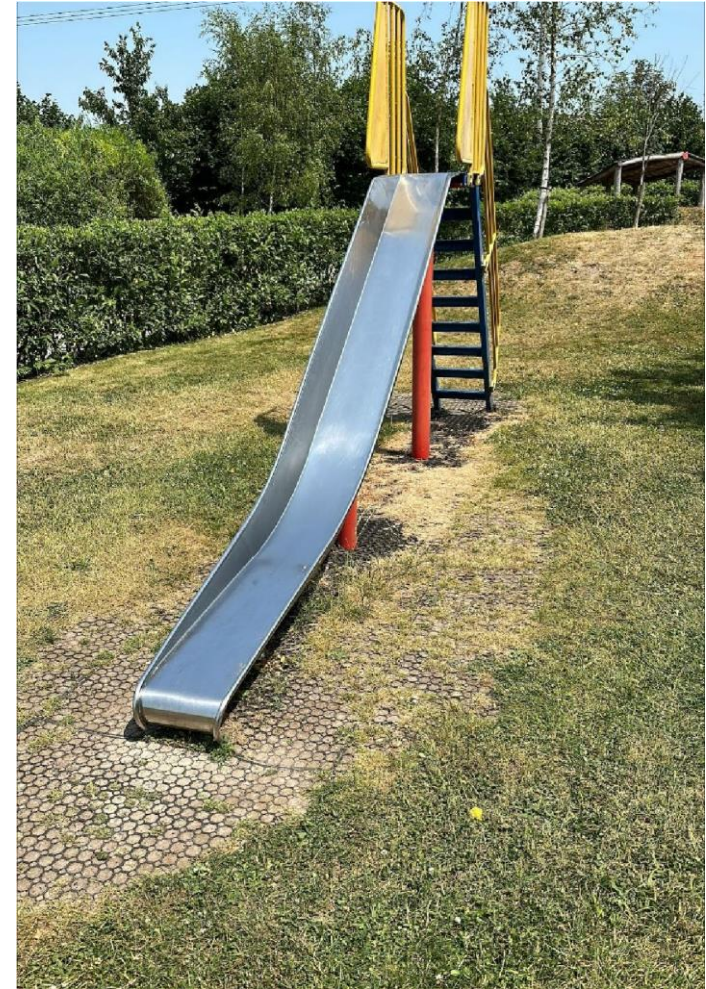
#### 4.2

This item predates the current BSEN1176 standards on entrapments and there is a potential entrapment between the risers. However, this is very low risk.

There are no other issues with this unit.

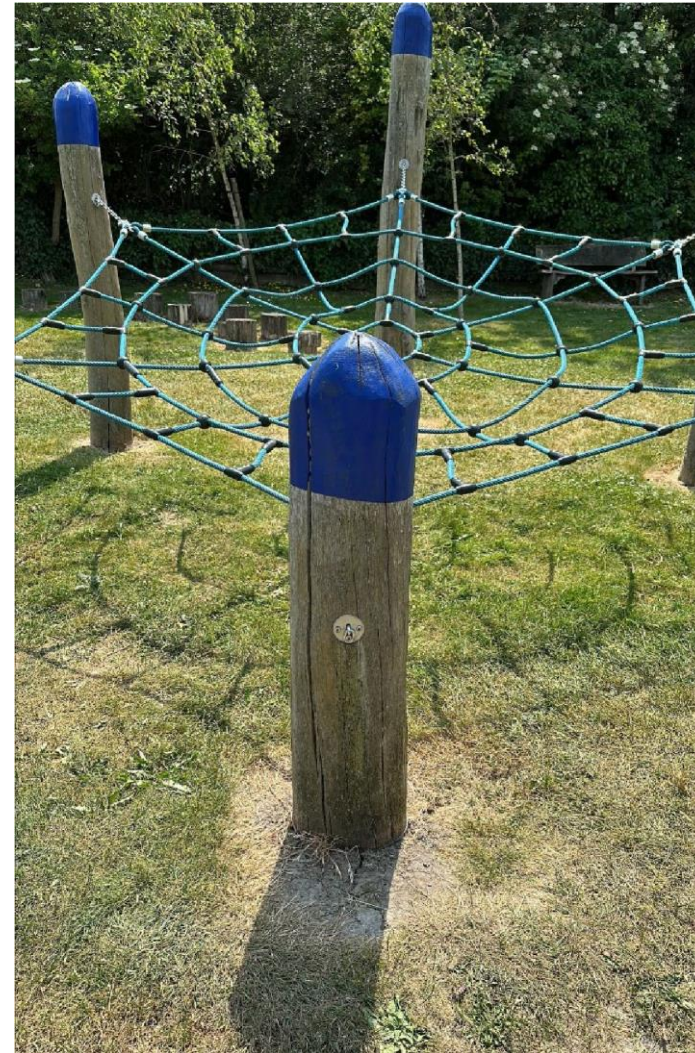
#### 4.3 ***Huck Spiders Web***

No issues

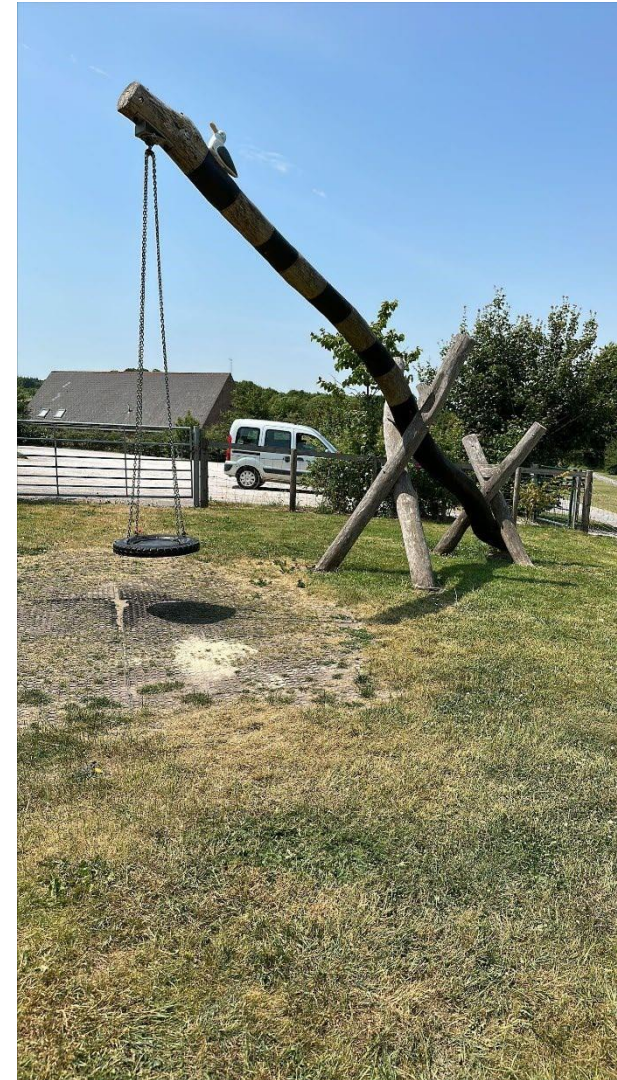
#### **4.4 *Spielart Cantilever Swing***

There are no significant issues with this unit.

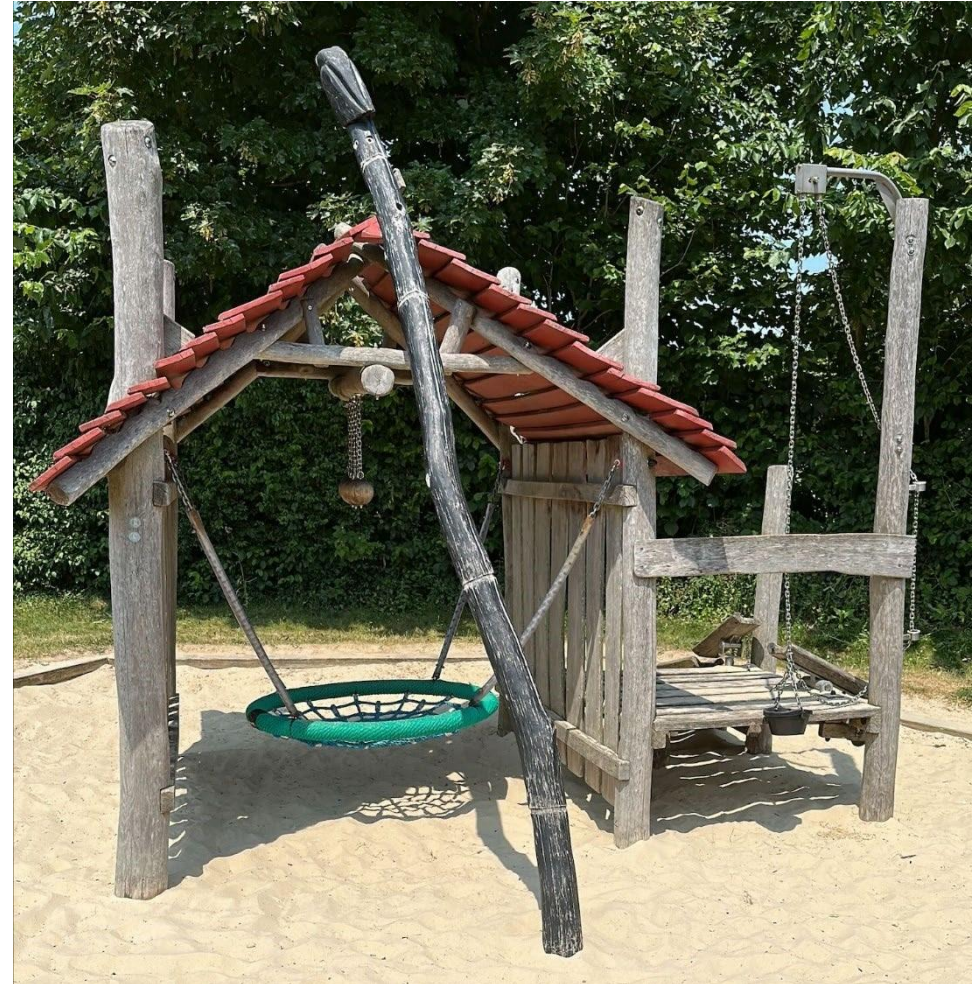
### 3.5 *Spielart Gnome Smithy Playhouse*

There are no issues with this unit.

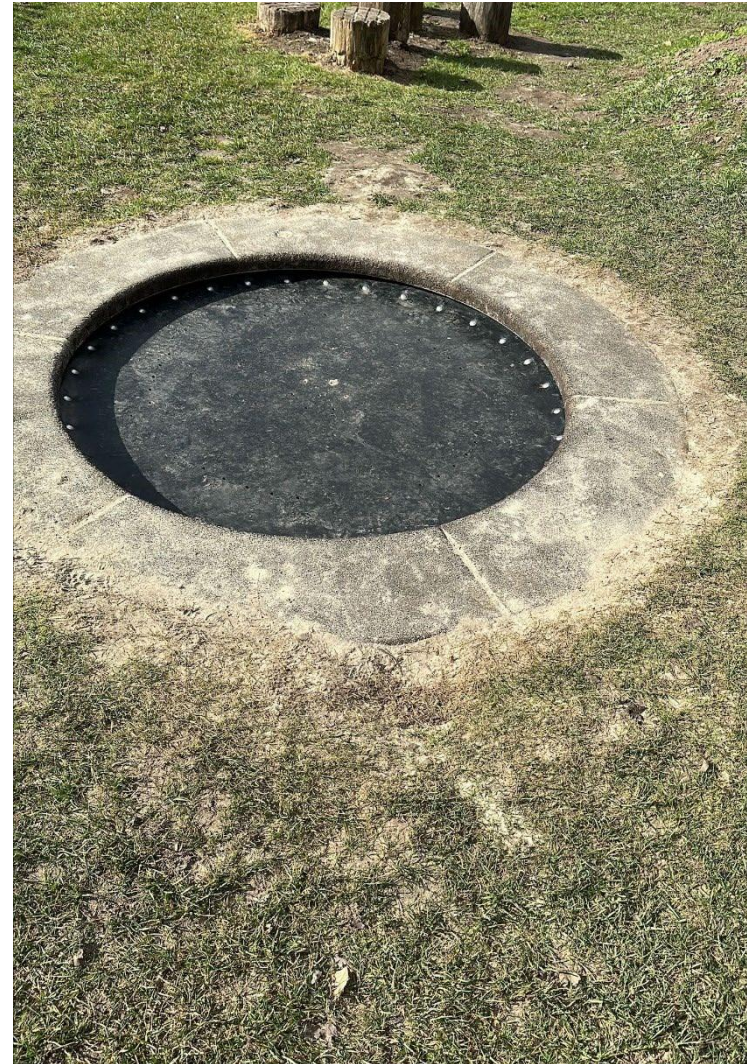
#### 4.6 *Huck Circus Trampoline*

There are no issues with this unit.

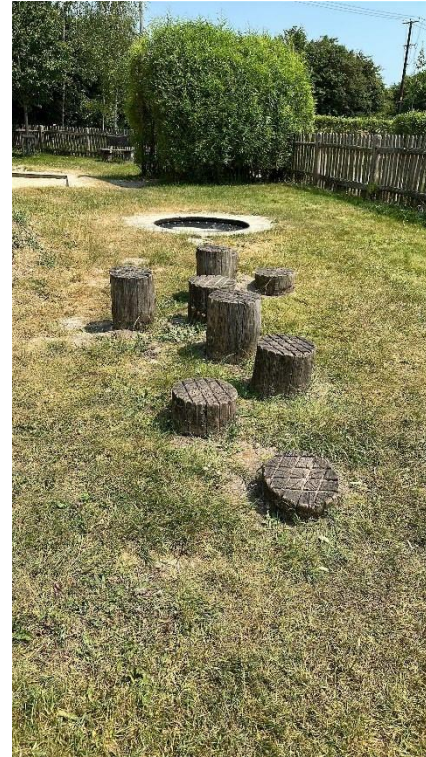
#### 4.7 **Wooden Stepping Logs**

There are no issues with this unit.

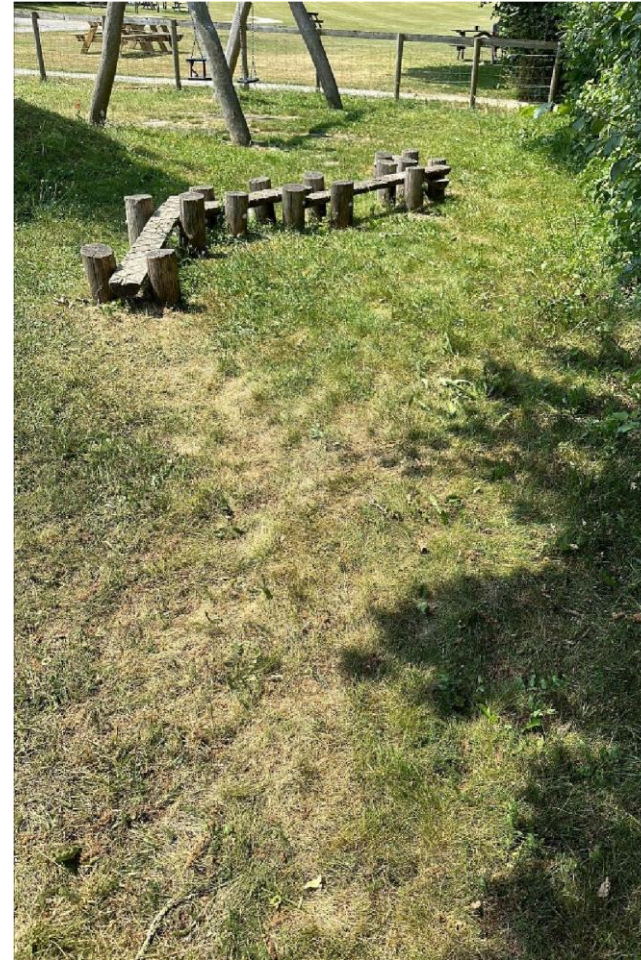
#### 4.8 **Balance Trail**

There are no issues with this unit.

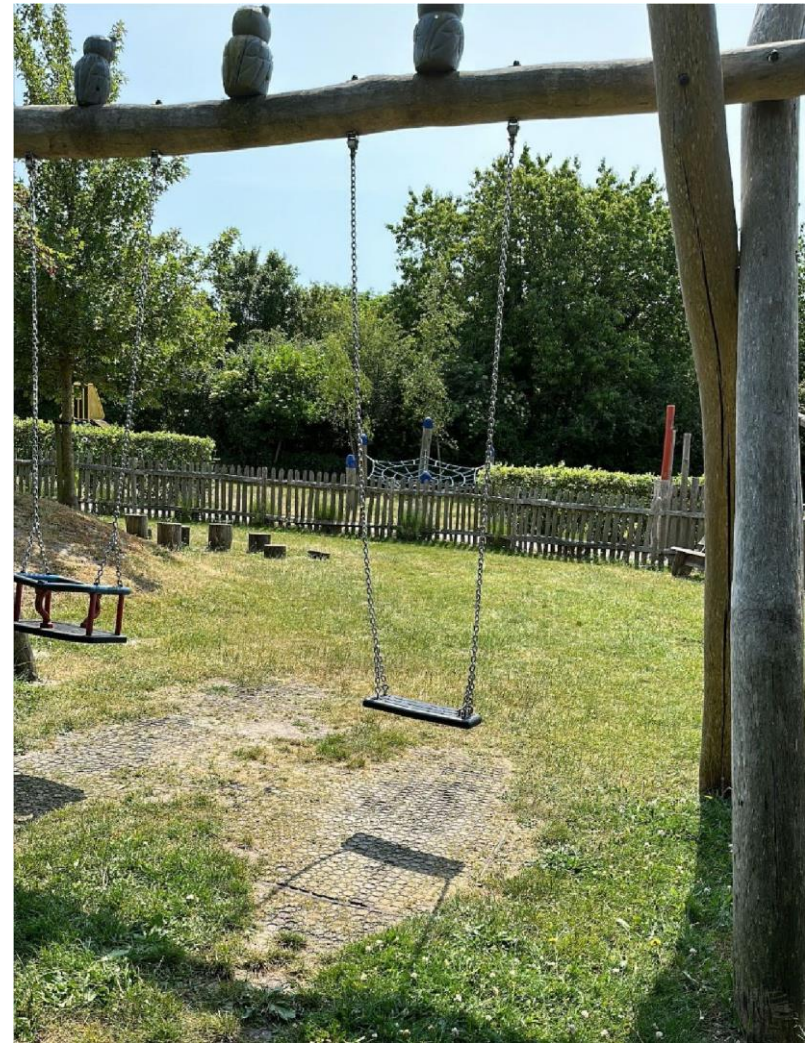
#### **4.9 *Spielart Double Swing Frame***

There is some corrosion staining appearing on the toddler seat.

There are no other issues with this unit.

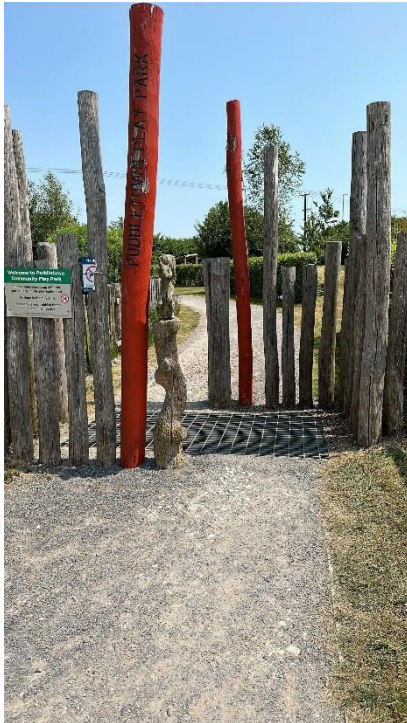
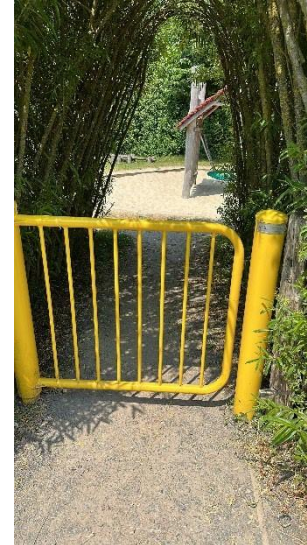
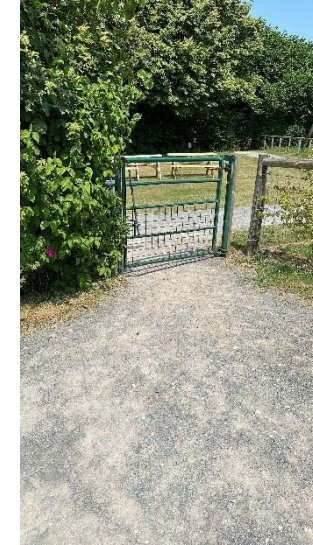
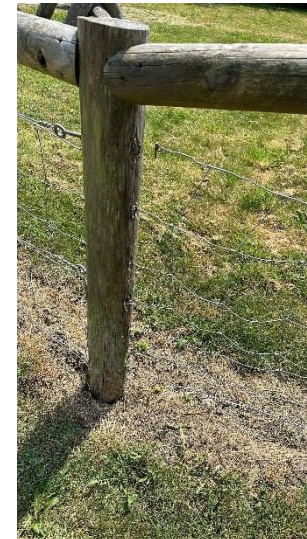
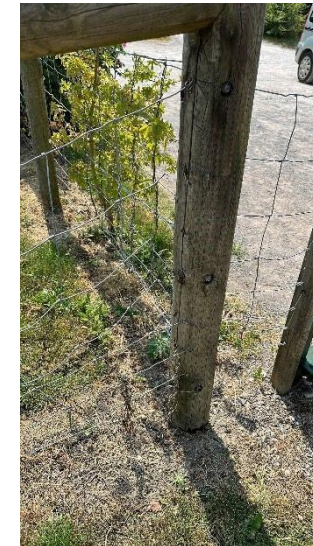
## 4.10 Fencing & Gates

| Item | Issues | Recommendation (s) |
|---|---|---|
| 4.10 | Large mesh allows the fence to be climbed | Fit smaller gauge mesh to prevent climbing / Plant fence line |
| 4.10 | Mesh is broken leaving pointed ends | Replace broken sections |

The mesh stock fencing has breaks in it leaving hazardous pointed ends and needs to be replaced.

Consideration should be given to planting to prevent the climbing hazard caused by the mesh fencing. The stock mesh fencing on at the entrance has a number of breaks and requires replacement / repair. When this light gauge fencing breaks it leaves pointed ends which can be a hazard to young children.

There is only one entrance and exit to the toddler area via a Monohinge gate, which is functioning as expected.

Options for planting along the mesh fencing should be looked at.

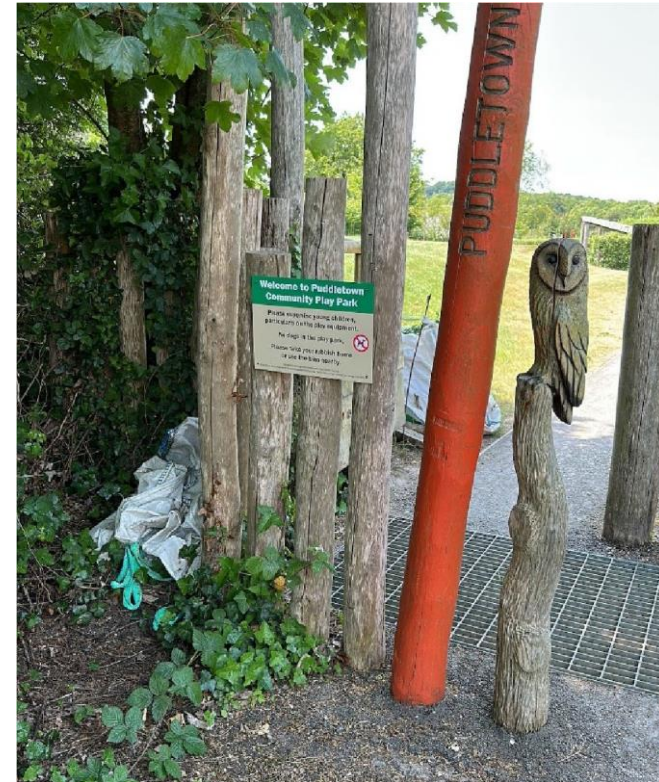
#### 4.11 Signs

Location and contact signs are present and suitable.

The sign warning of the presence of overhead power cables is clearly displayed and securely fixed.

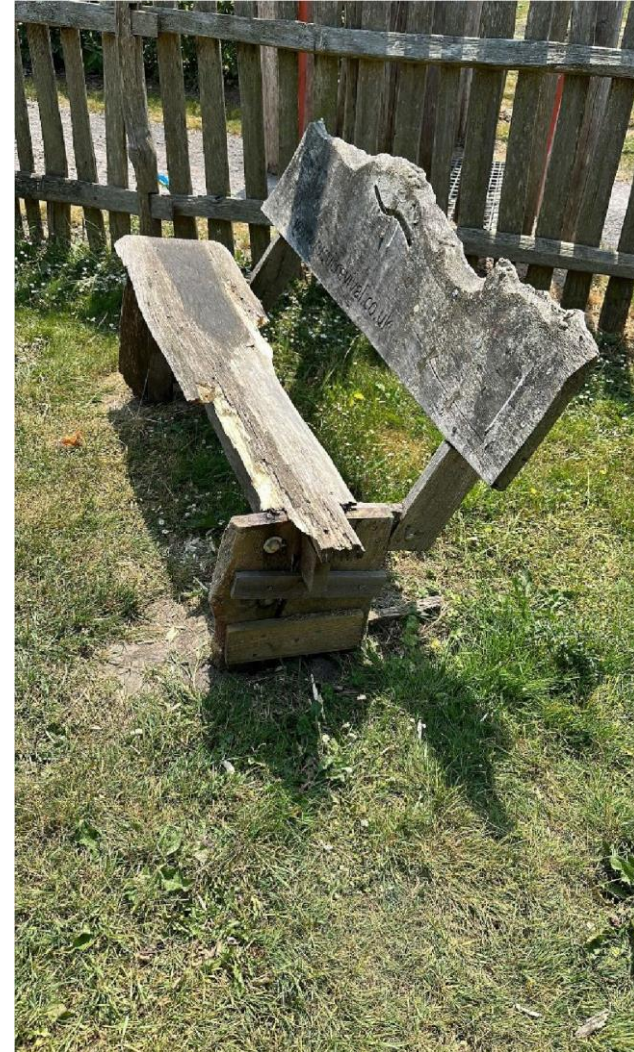
#### 4.12 Seating inc. Teen shelter

| Item | Issues | Recommendation (s) |
|---|---|---|
| 4.12 | Seating is too close to fencing and unstable | Remove / if replaced then relocate |
| 4.12 | Extensive areas of rot developing in bespoke seating | Remove or replace |

The benches and one picnic table are in a terminal state of repair and should be removed.

Most, if not all of the rustic seating originally installed is in need of removal and/or replacement. A heavy individual sitting forcibly on any of the seats may cause collapse and injury. The one picnic table sited within the play area is extremely unstable and should be removed.

It is difficult to see why some of the seats are still in place given their condition.

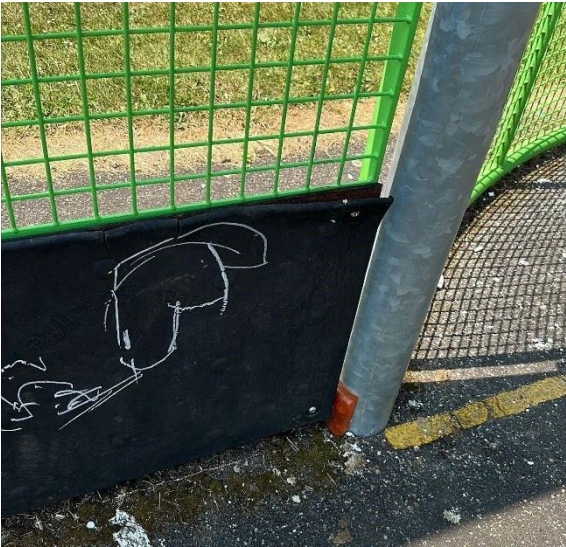
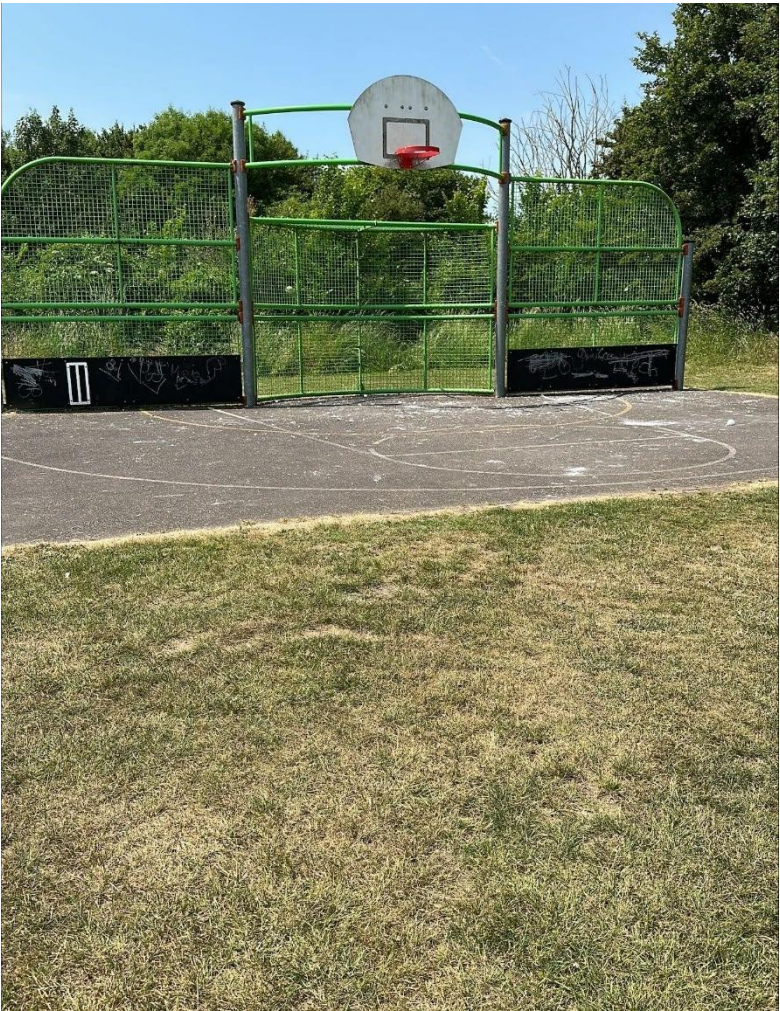
#### ***4.13 Sutcliffe Play MUGA End***

| Item | Issues | Recommendation (s) |
|---|---|---|
| 4.13 | Rebound panel corroded | Repalce |

The recommended sign advising against climbing is not present. .

Sports England guidance on signs recommends that a sign is displayed with the wording below. Such a sign is not currently displayed.;

*“Do not climb on the framework and do not hang on the ring”*

A replacement panel for the Muga is on order.

The rebound panel is scheduled for replacement.
